LAC CATALINA DAM

MO 30286

ST. FRANCOIS COUNTY, MISSOURI

PHASE 1 INSPECTION REPORT NATIONAL DAM SAFETY INSPECTION

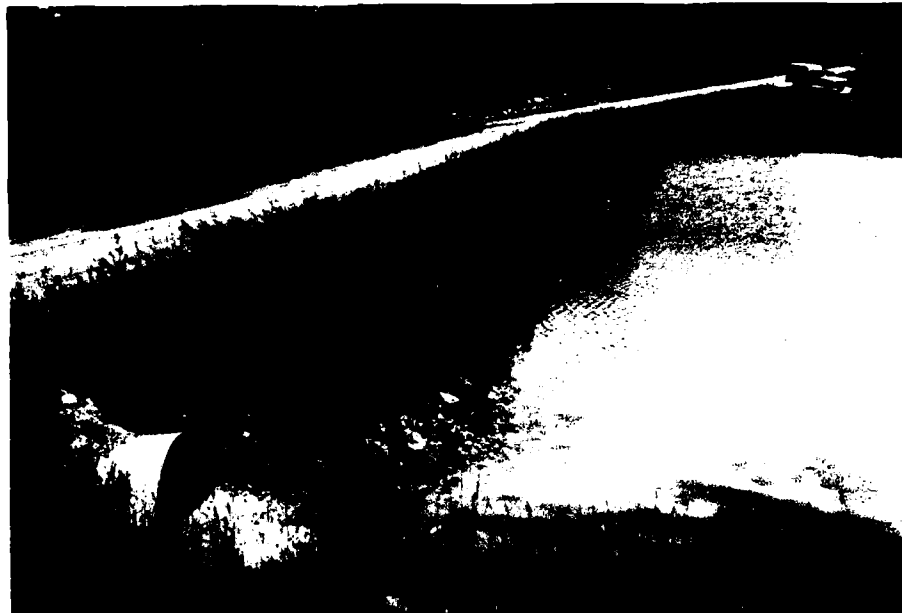
4. The upstream face of the dam has a grass cover to prevent erosion. However, at the lake waterline, some minor erosion of the slope has occurred. Continued erosion of the embankment could result in loss of section that may lead to instability of the slope and possible failure of the dam.

c. Dam. The visible portions of the upstream and downstream faces of the dam (see Photos 1 and 2) appeared to be in sound condition although some minor erosion of the unprotected upstream slope at the waterline was noticed. The downstream slope had a dense cover of grass that was about 30 inches high at the time of the inspection. The roadway that traverses the dam crest was surfaced with gravel that was thinly distributed and some rutting of the surface was observed.

NO. 1: UPSTREAM FACE OF DAM

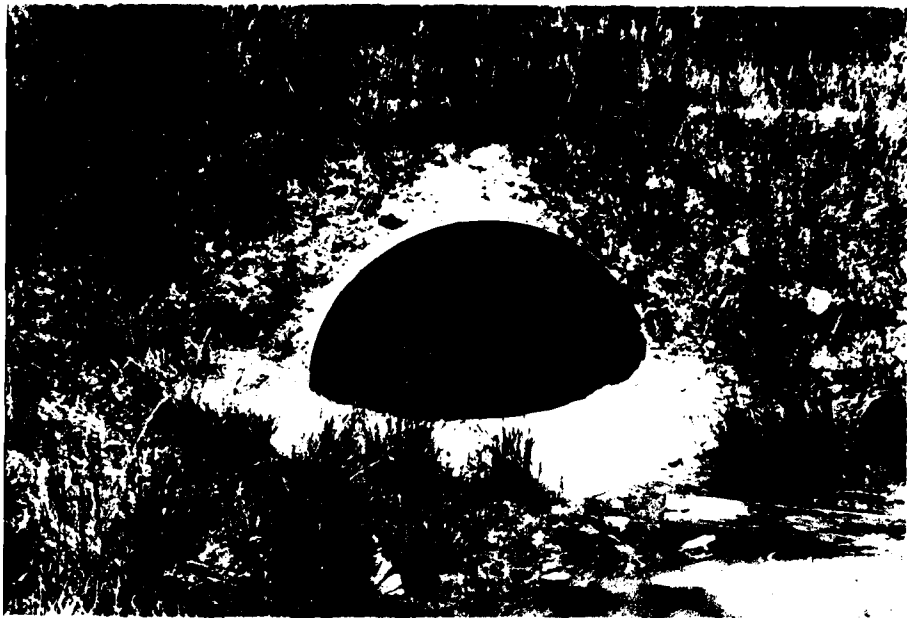
The 44-inch high by 72-inch wide corrugated metal spillway pipe appeared to be in satisfactory conditions (see Photos 3 and 4), although the downstream end of the pipe was unsupported for a distance of about 2 feet. A concrete apron, about 5 feet long and in good condition, serves to prevent erosion at the lake approach to the spillway pipe. At a point below the outlet end of the spillway pipe, debris, consisting of large boards and refuse bags, (see Photo 4) was lodged in the channel. Stone riprap up to 5 cubic feet in size has been placed within the channel section for a distance of about 60 feet below the spillway pipe. Downstream and within the riprap protected section, the banks of the spillway channel (see Photo 5) were noticeably eroded in several locations.

NO. 3: UPSTREAM END OF SPILLWAY PIPE
